February 4, 2015

ESI Project: 47357A

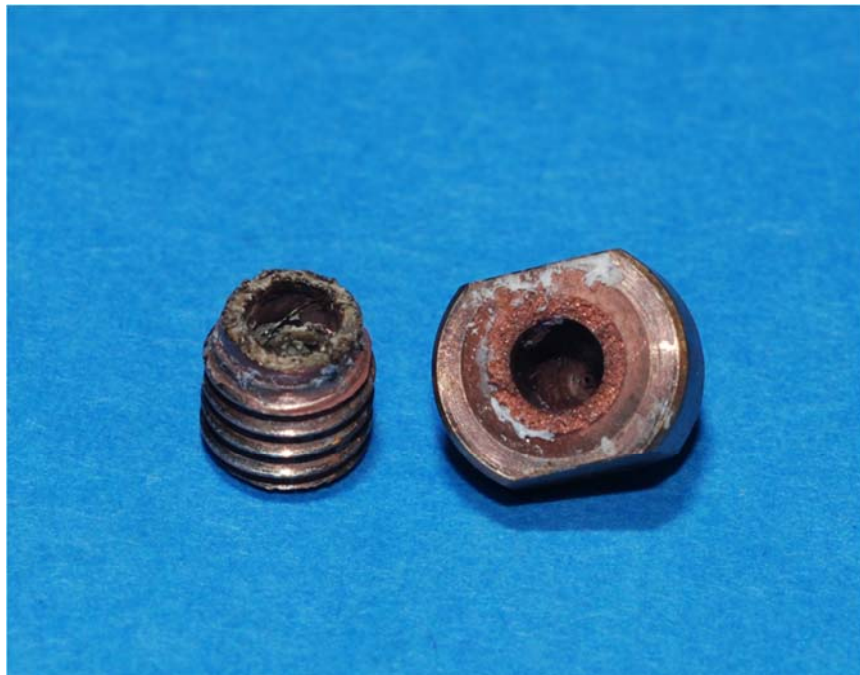
**Figure 1.** Nozzle A in the as-received condition.

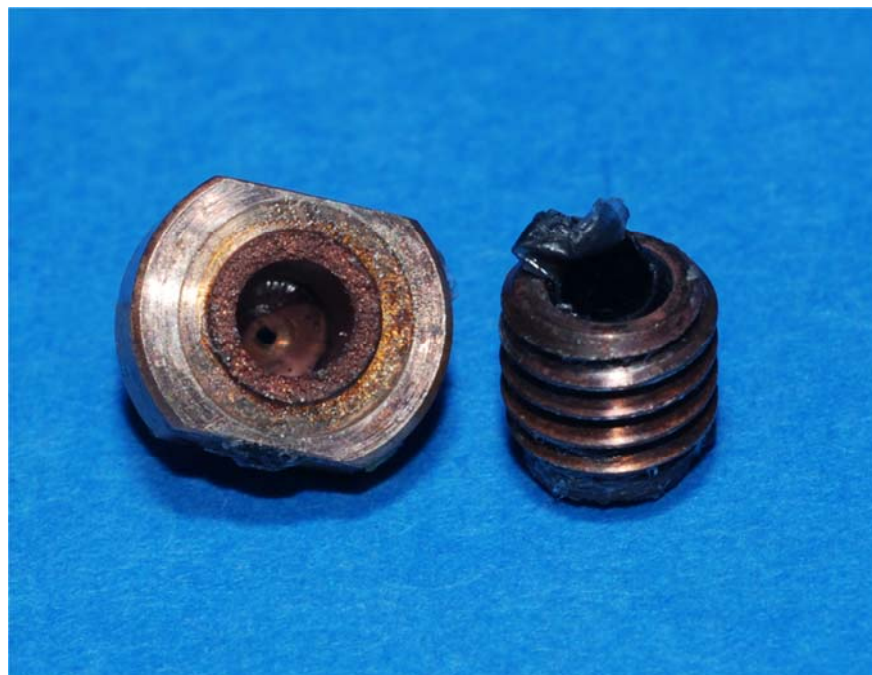
**Figure 2.** Nozzle B in the as-received condition.

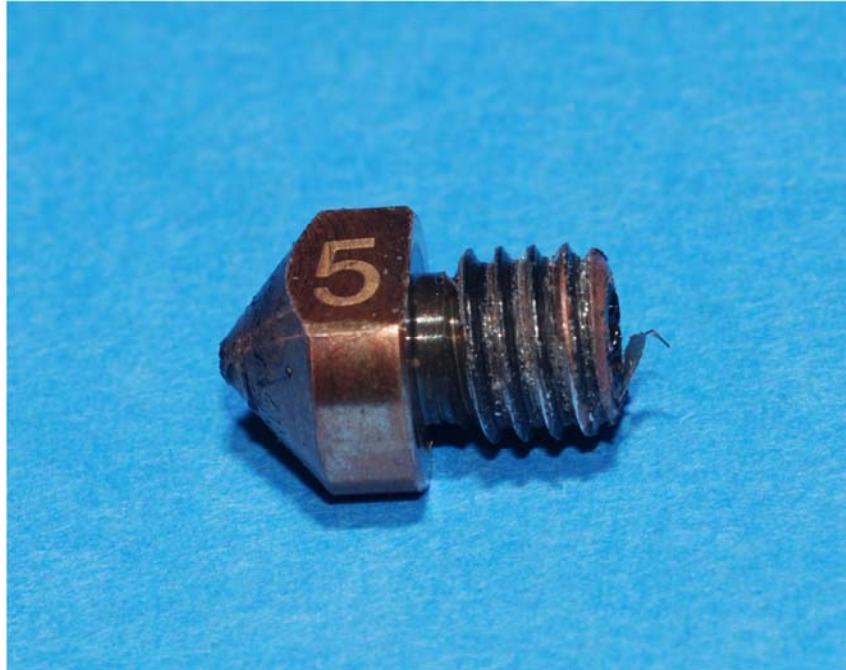
**Figure 3.** Nozzle C in the as-received condition.

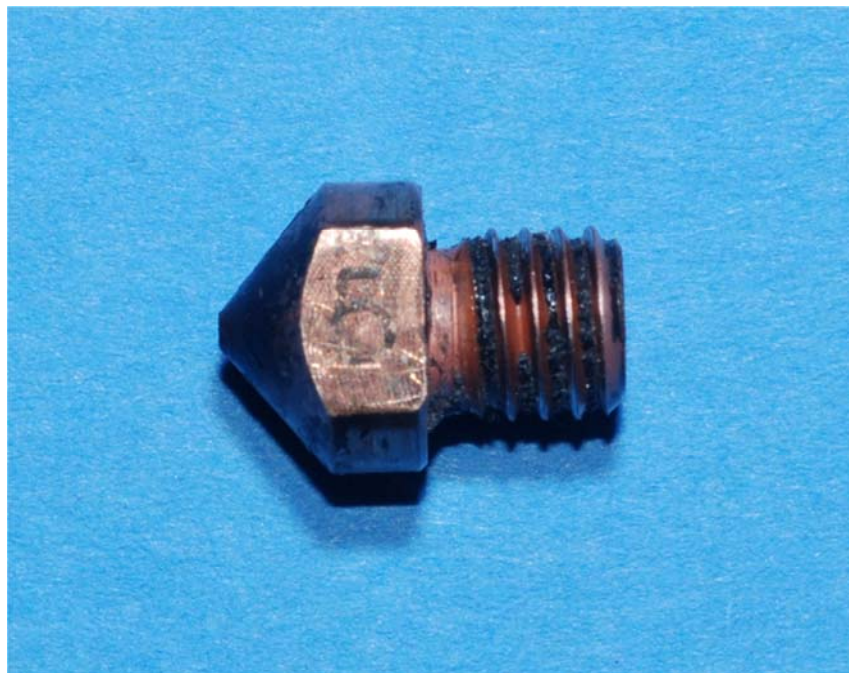
**Figure 4.** Nozzle D in the as-received condition.

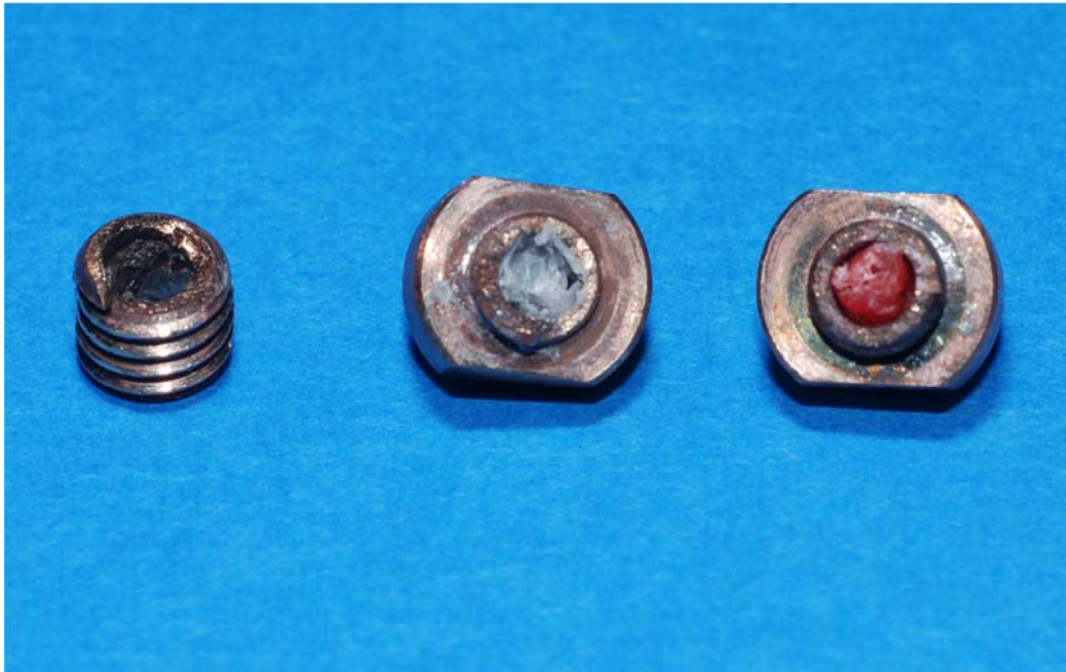
**Figure 5.** Nozzles E in the as-received condition.

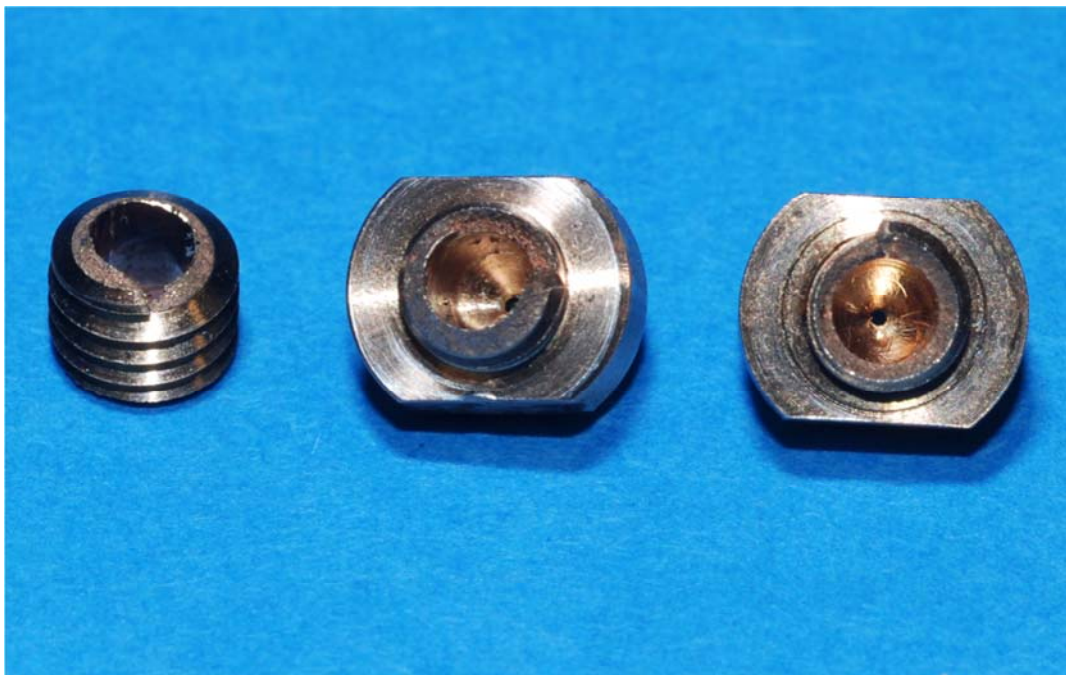
**Figure 6.** Nozzles F in the as-received condition.

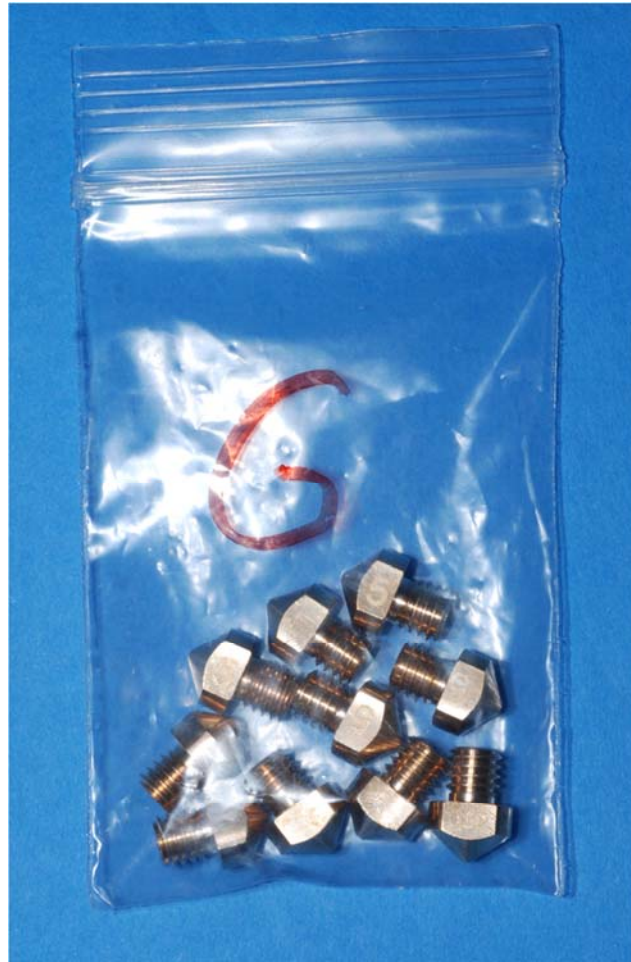
**Figure 7.** Nozzles G in the as-received condition.

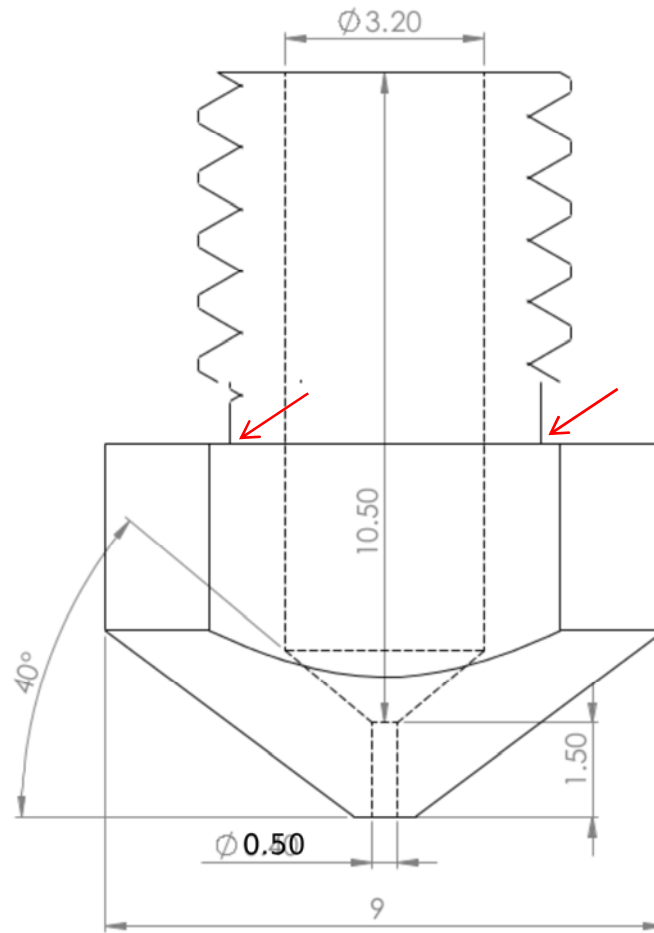
**Figure 8.** Design drawing for the subject nozzle showing the corner at the junction between the threaded section and head and the location of a stress riser (indicated by a red arrows).

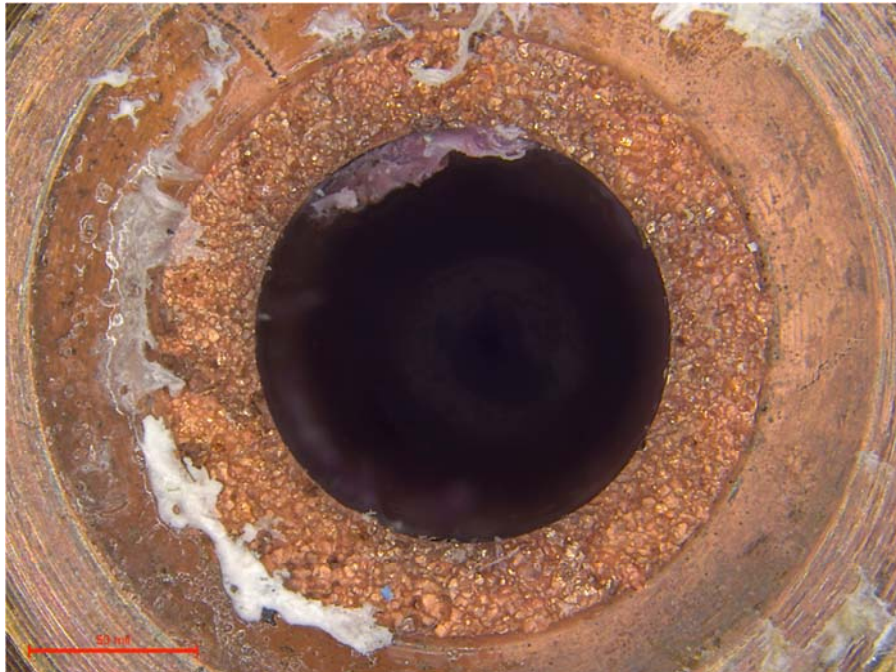
**Figure 9.** Stereo-optical microscopy image of the fracture surface of nozzle A showing characteristics (reflectivity) of intergranular fracture.

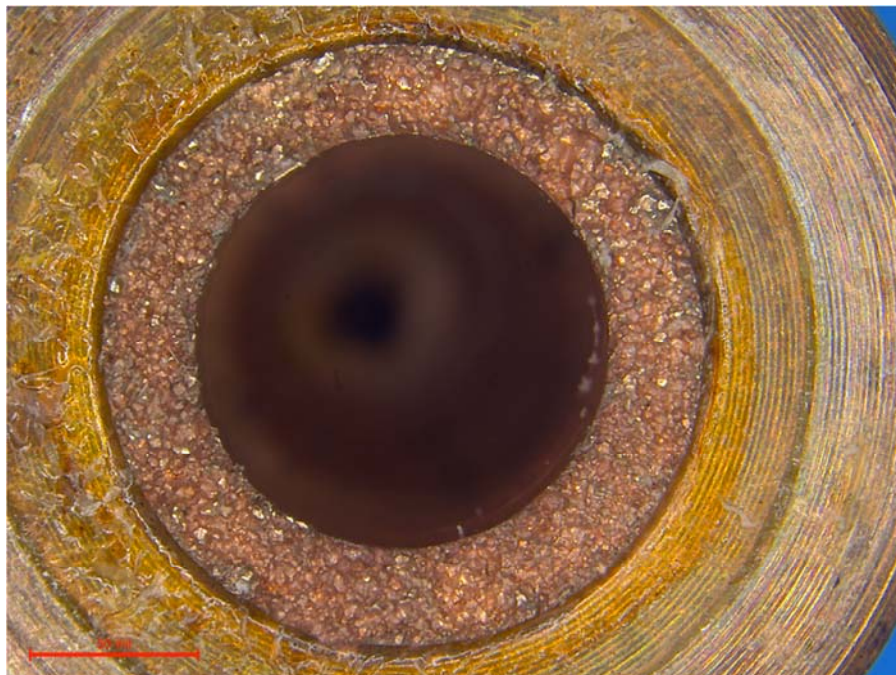
**Figure 10.** Stereo-optical microscopy image of the fracture surface of nozzle B showing characteristics of intergranular fracture.

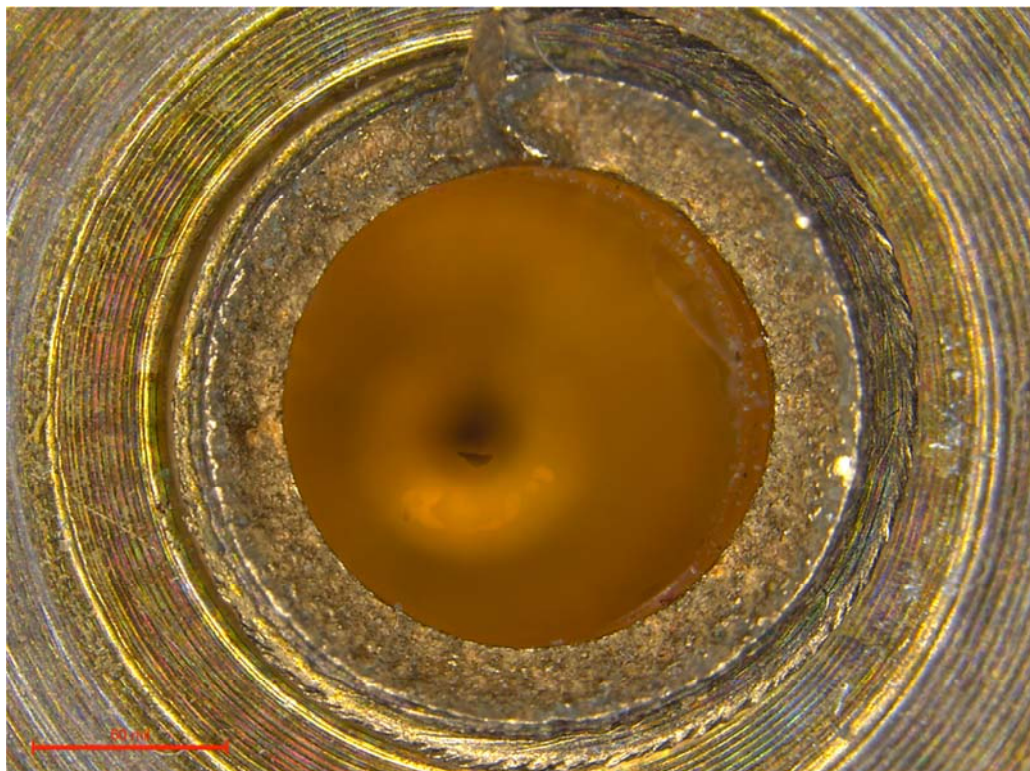
**Figure 11.** Stereo-optical microscopy image of the fracture surface of nozzle F showing characteristics (dull, matte appearance) of ductile overload failure.

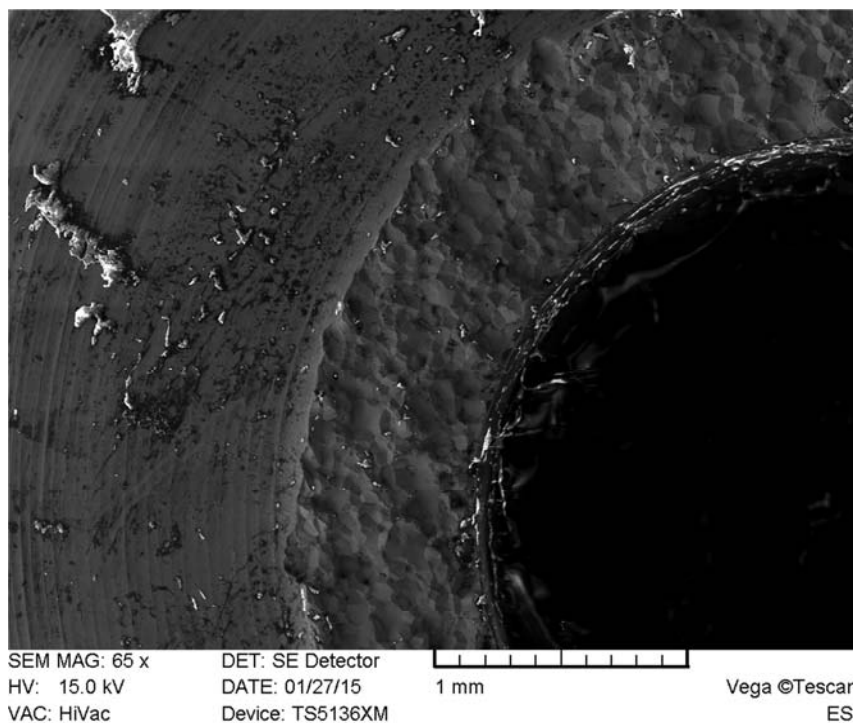
**Figure 12.** SEM image of the fracture surface of nozzle A showing characteristics of intergranular fracture.

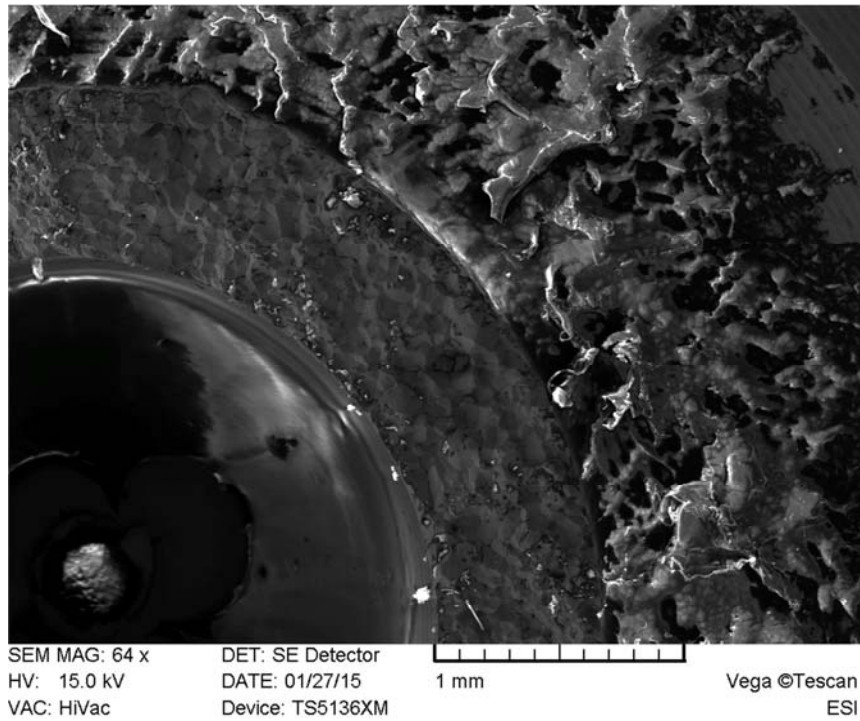
**Figure 13.** SEM image of the fracture surface of nozzle B showing characteristics of intergranular fracture.

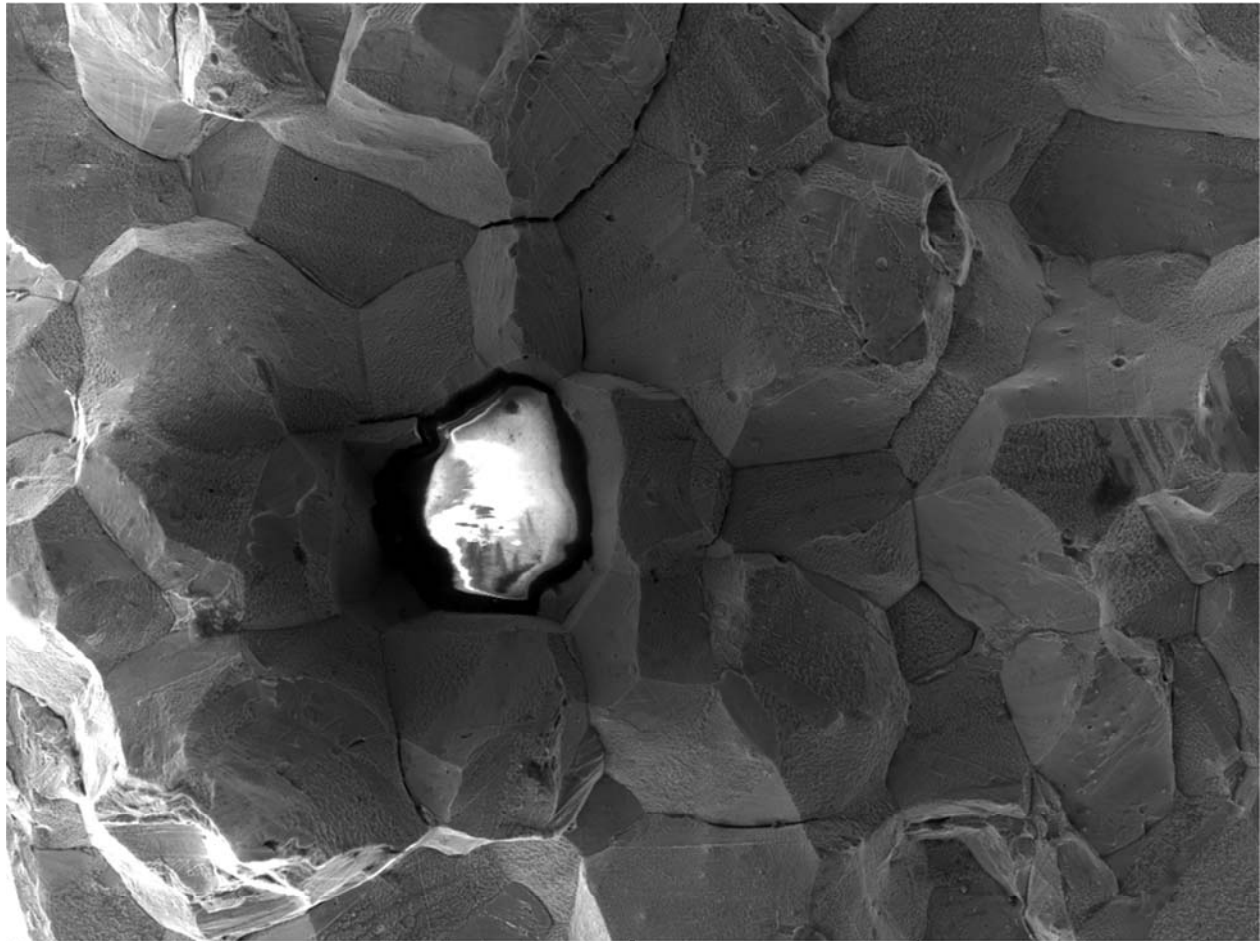
SEM MAG: 499 x  
HV: 15.0 kV  
VAC: HiVac

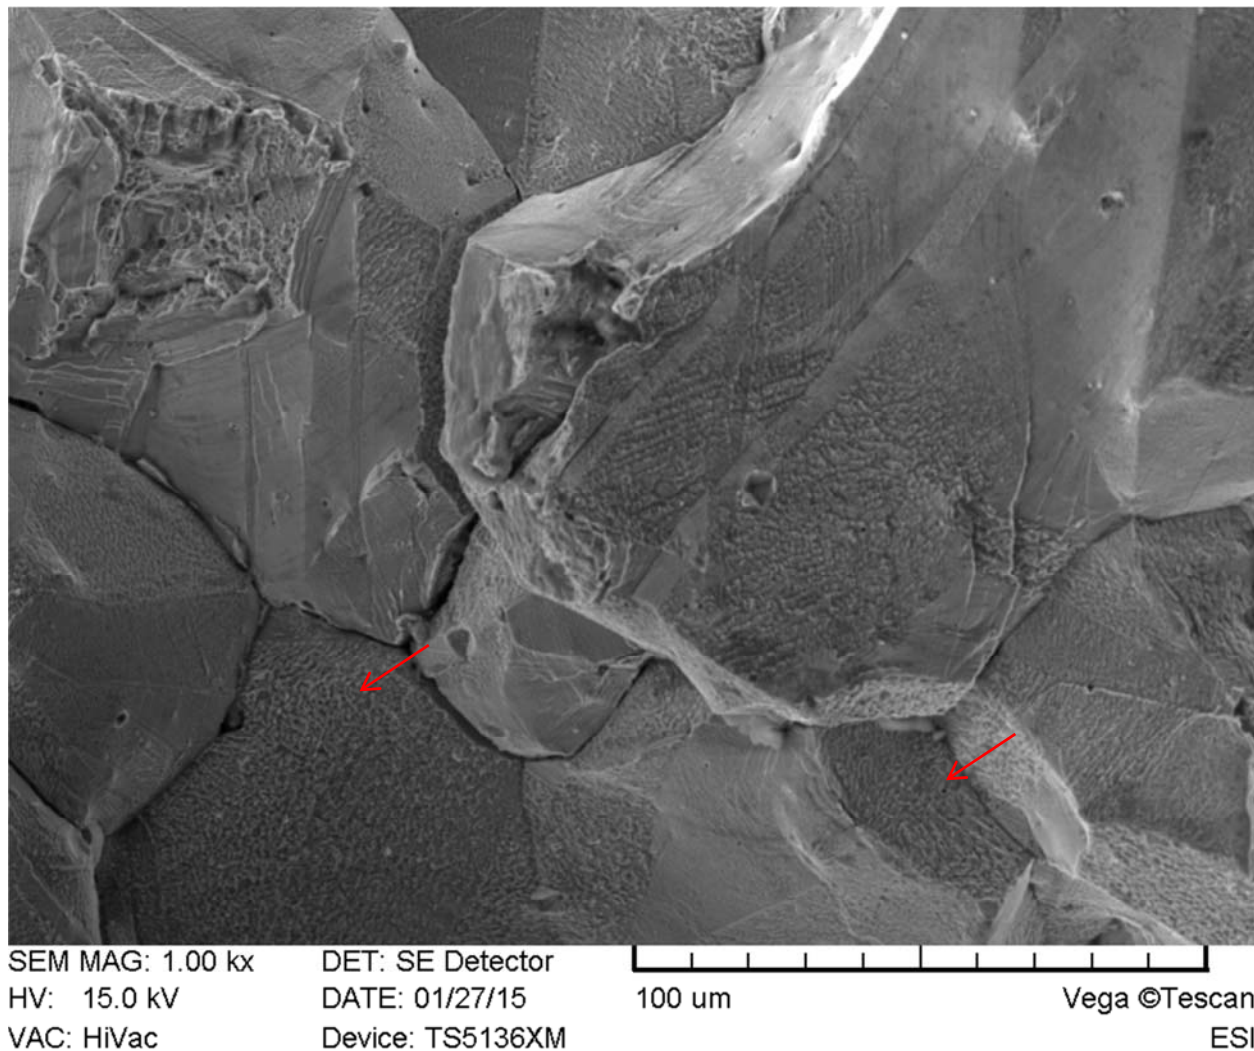
**Figure 15.** SEM image of the fracture surface of nozzle B showing intergranular fracture and dimpled rupture of the grain boundary surfaces (identified with red arrows).

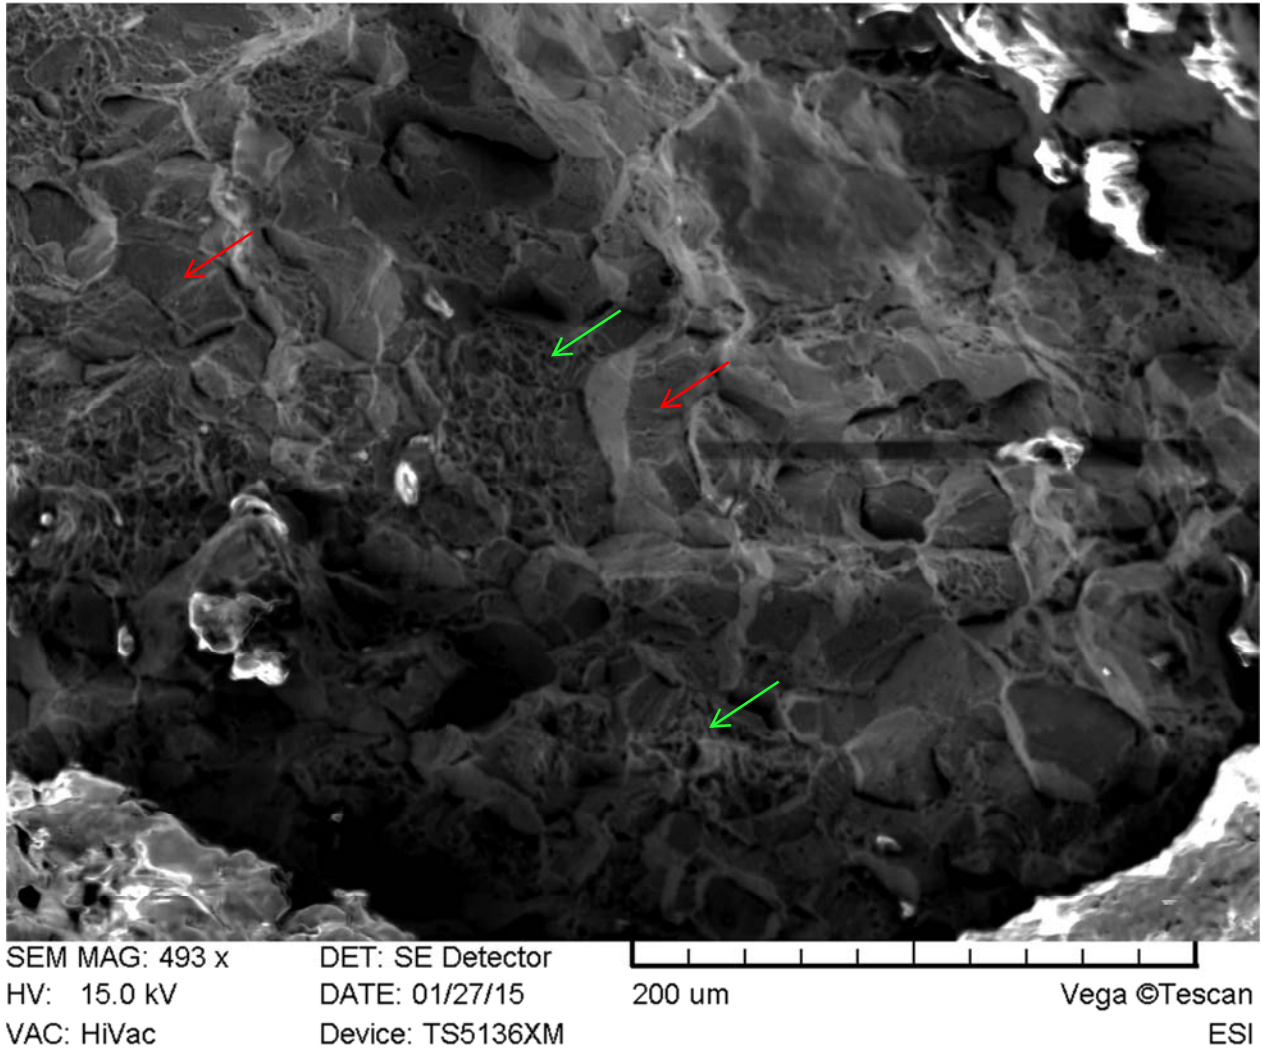
**Figure 16.** SEM image of the fracture surface of nozzle F showing mixed mode intergranular fracture (identified with red arrows) and dimpled rupture of ductile overload (identified with green arrows).

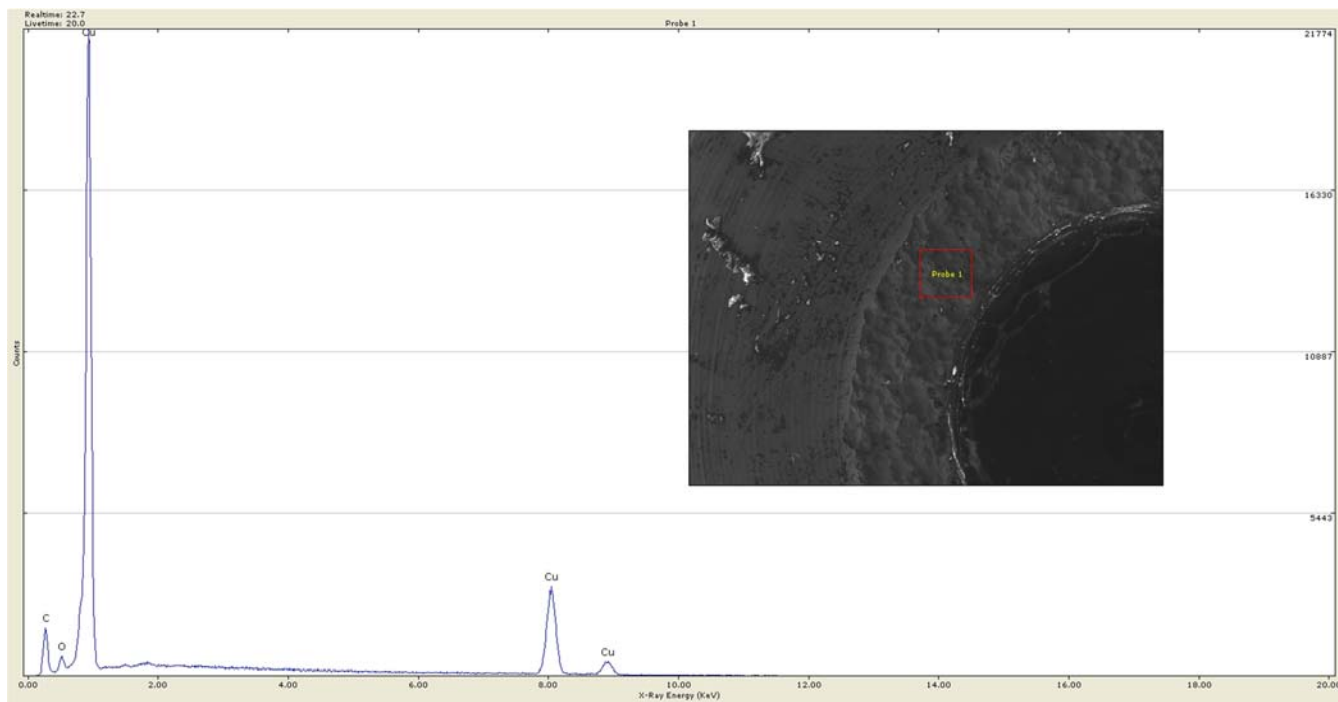
**Figure 17.** EDS spectra and locator map for the analysis of nozzle A showing the presence of copper, oxygen, and carbon.

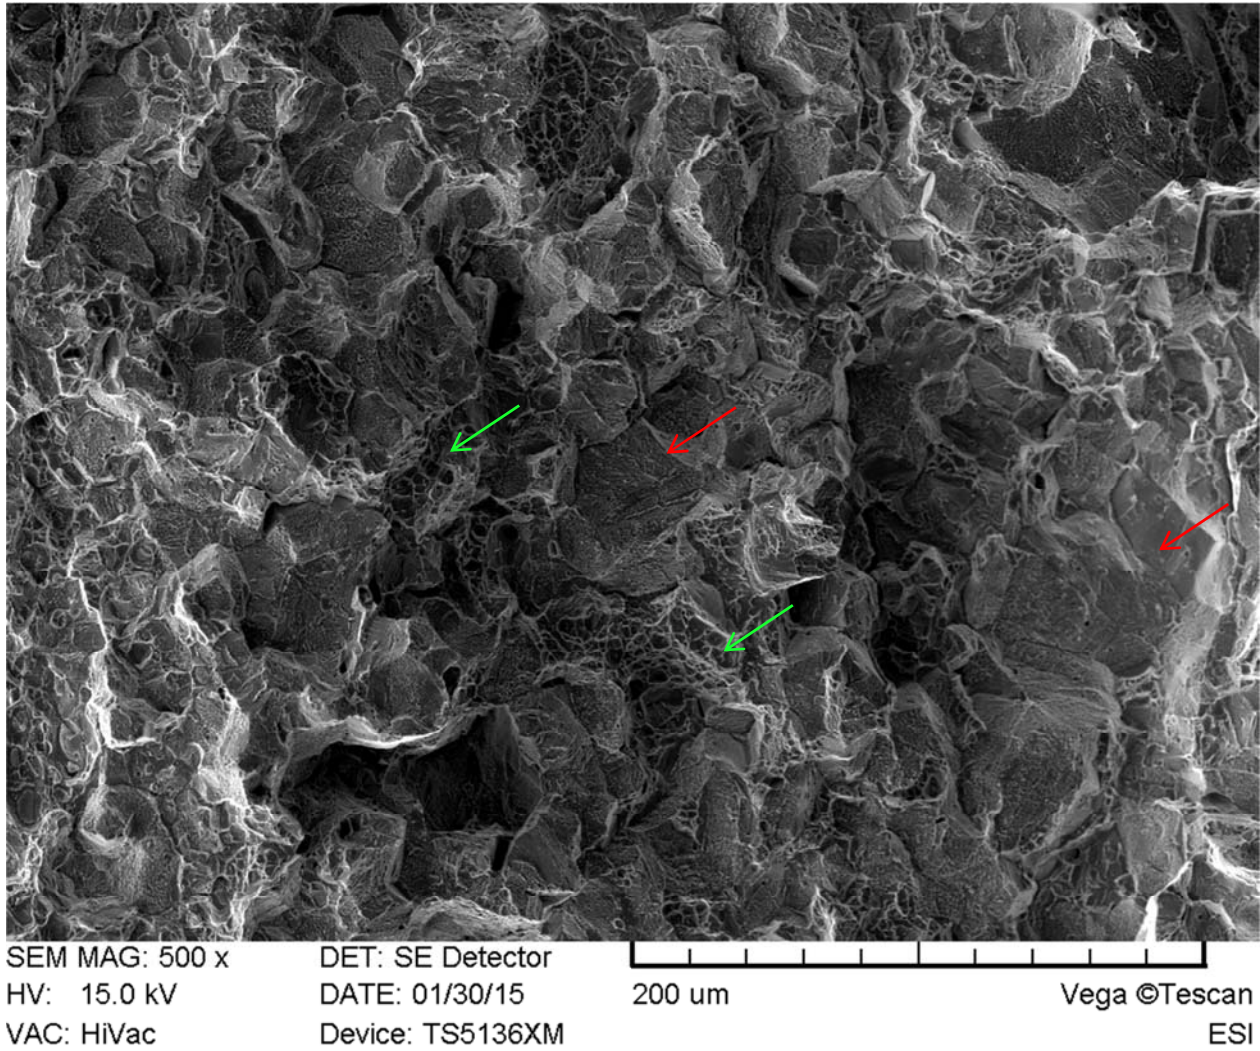
**Figure 19.** SEM image of the fracture surface of the threaded section of nozzle G showing mixed mode intergranular fracture (identified with red arrows) and dimpled rupture of ductile overload (identified with green arrows).

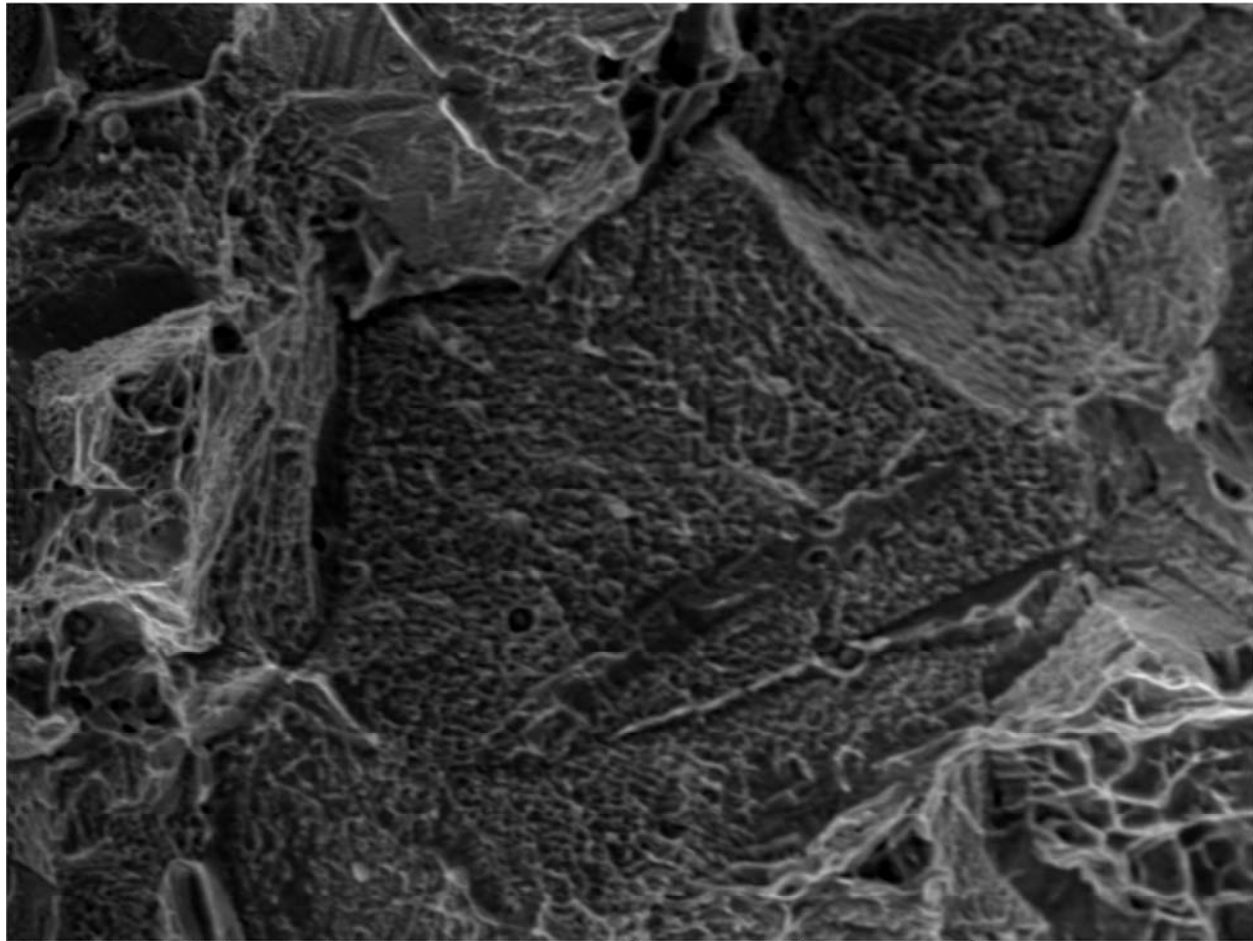
SEM MAG: 2.99 kx      DET: SE Detector      20 um  
HV: 15.0 kV      DATE: 01/30/15  
VAC: HiVac      Device: TS5136XM      Vega ©Tescan  
ESI

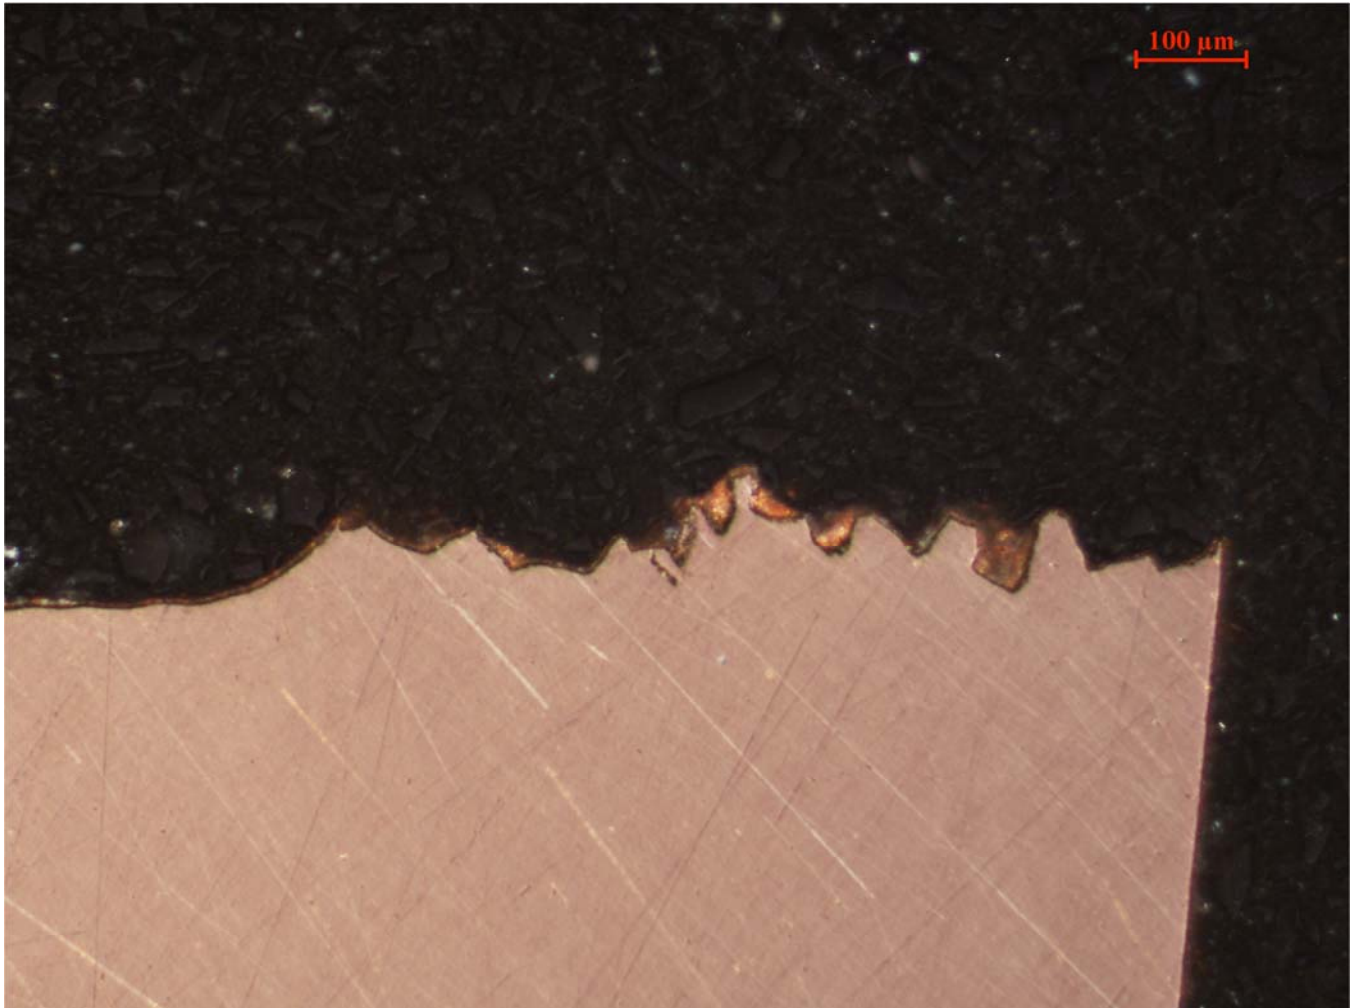
**Figure 21.** Metallography of the cross section of the head of nozzle A at the fracture surface showing a lack of branch cracking, which would be indicative of SCC.

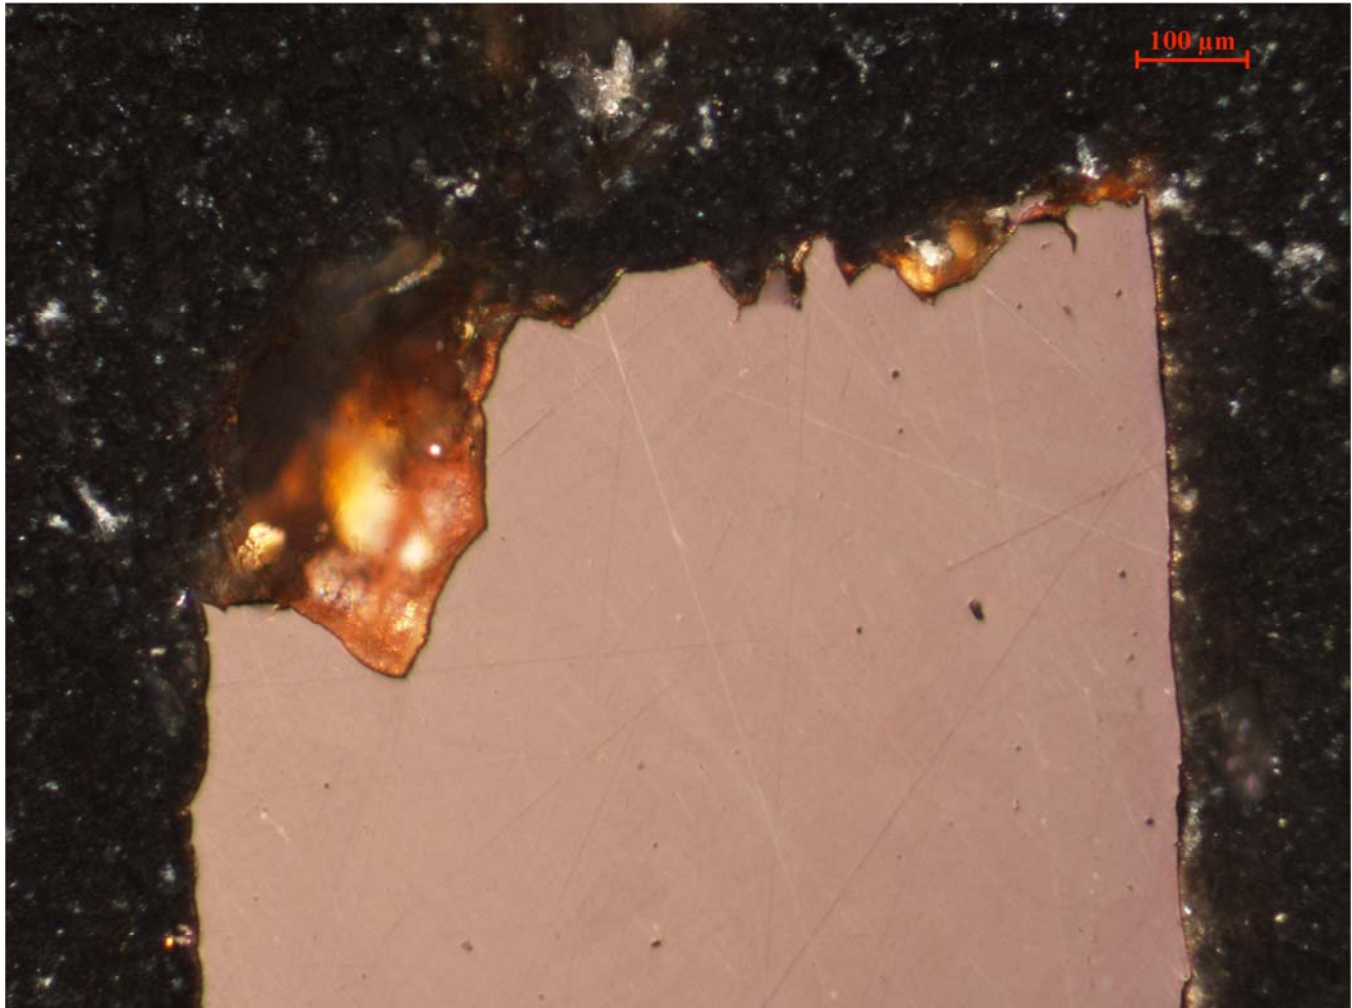
**Figure 22.** Metallography of the cross section of the threaded section of nozzle A at the fracture surface showing a lack of branch cracking.

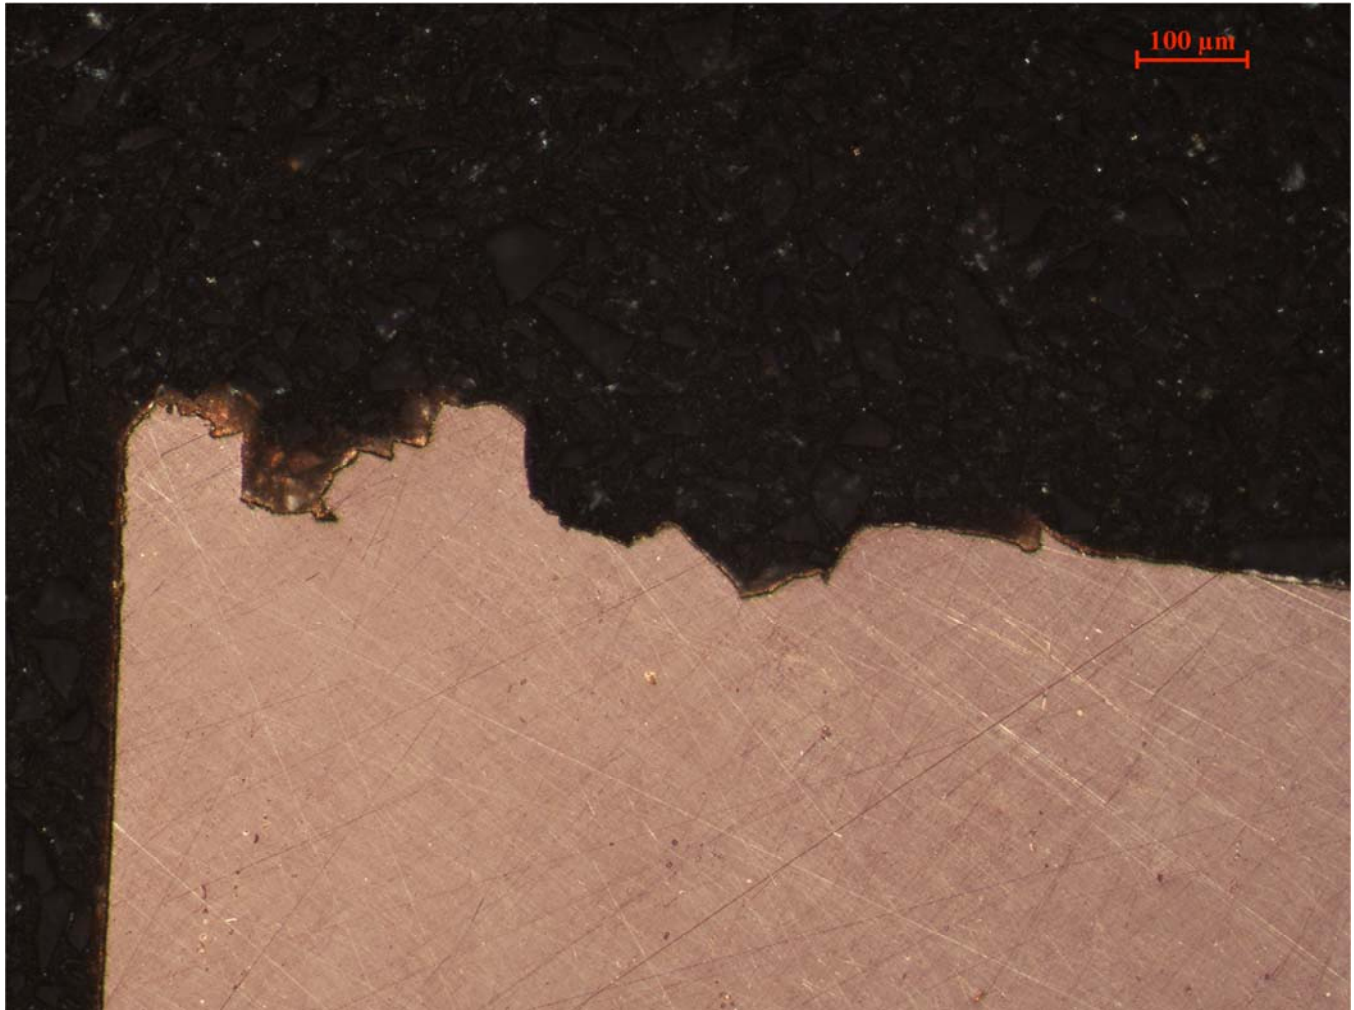
**Figure 23.** Metallography of the cross section of the head of nozzle B at the fracture surface showing a lack of branch cracking.

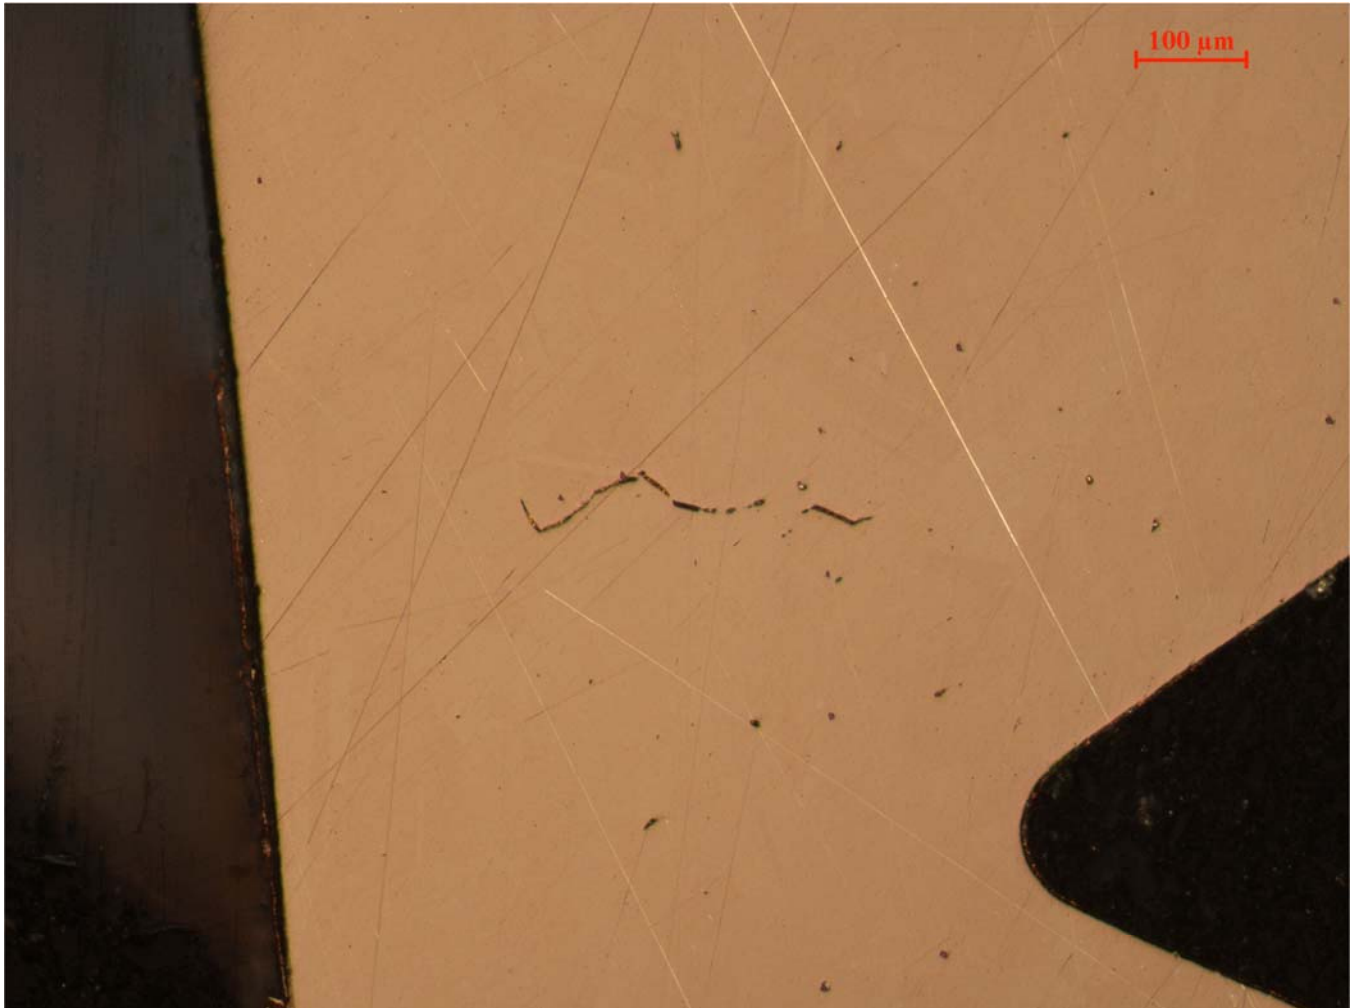
**Figure 24.** Metallography of the cross section of the threaded section of nozzle A showing grain boundary cracking as a series of interconnected voids.

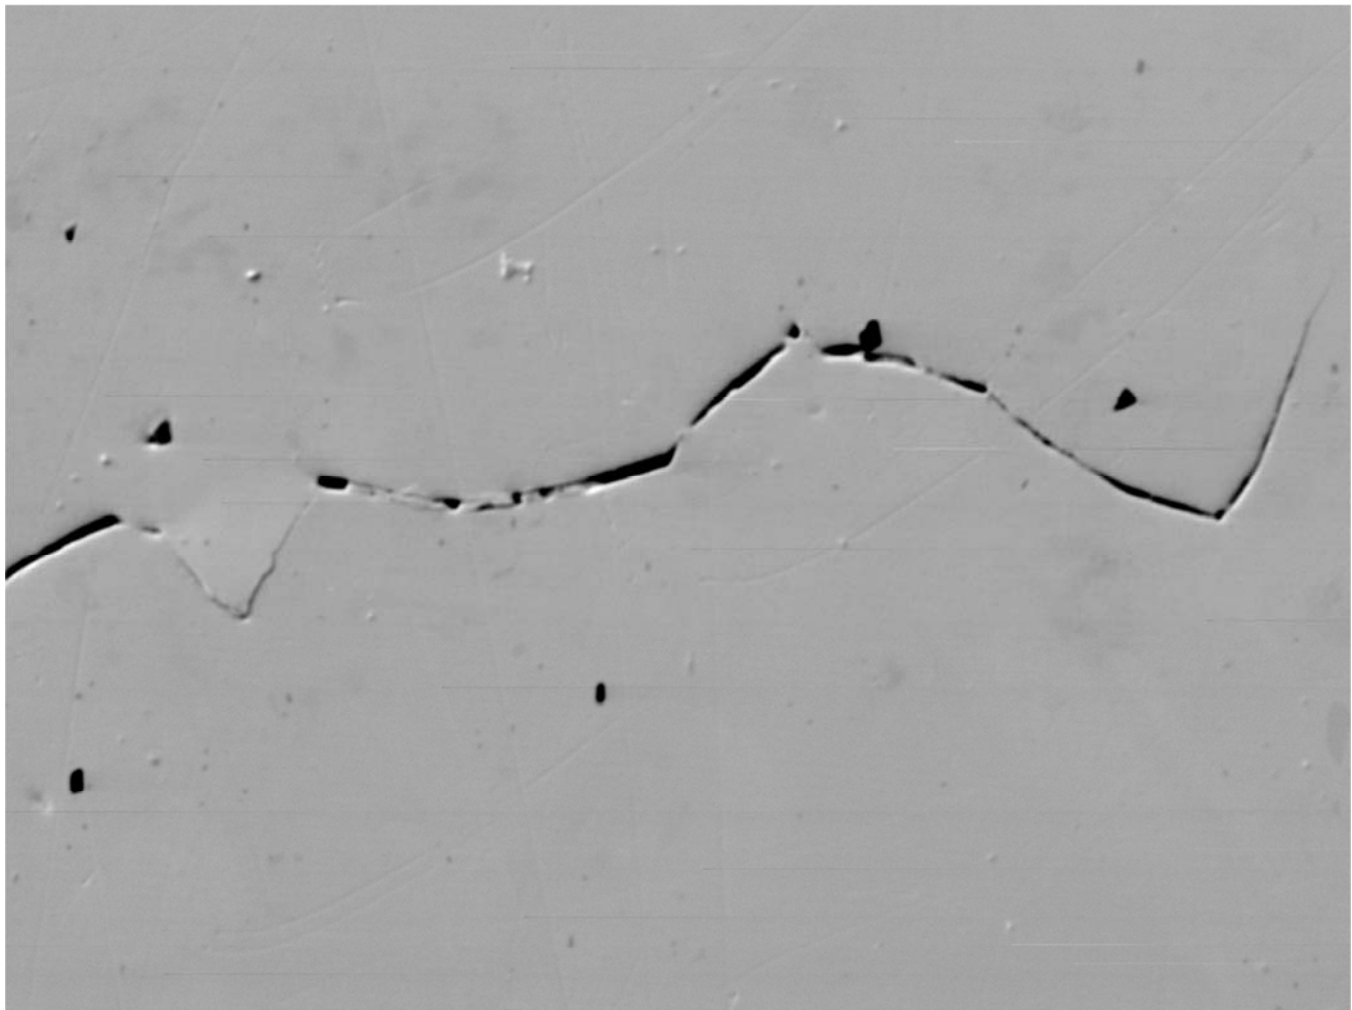
SEM MAG: 750 x  
DET: SE Detector  
HV: 15.0 kV
