February 4, 2015

ESI Project: 47357A

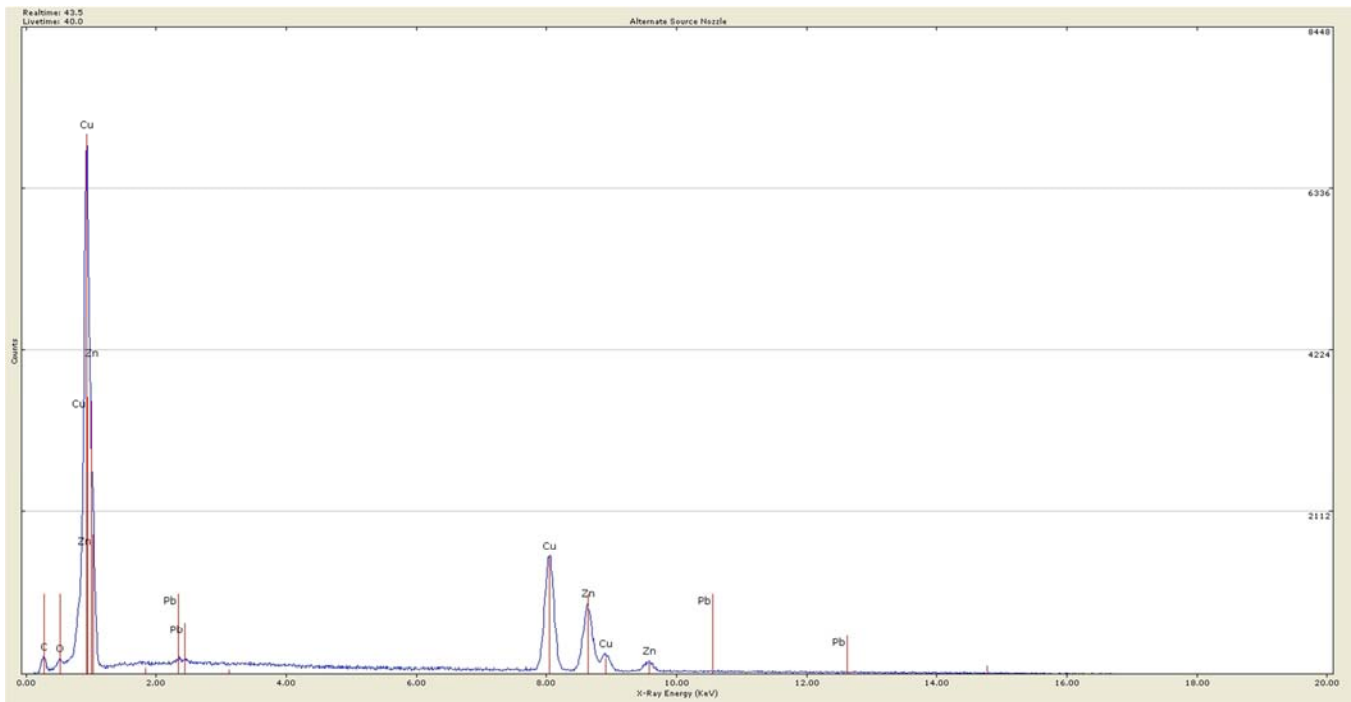
**Figure 26.** EDS spectra for the analysis of the alternatively sourced nozzle showing the presence of copper, zinc, lead, oxygen, and carbon, indicative of a brass alloy.

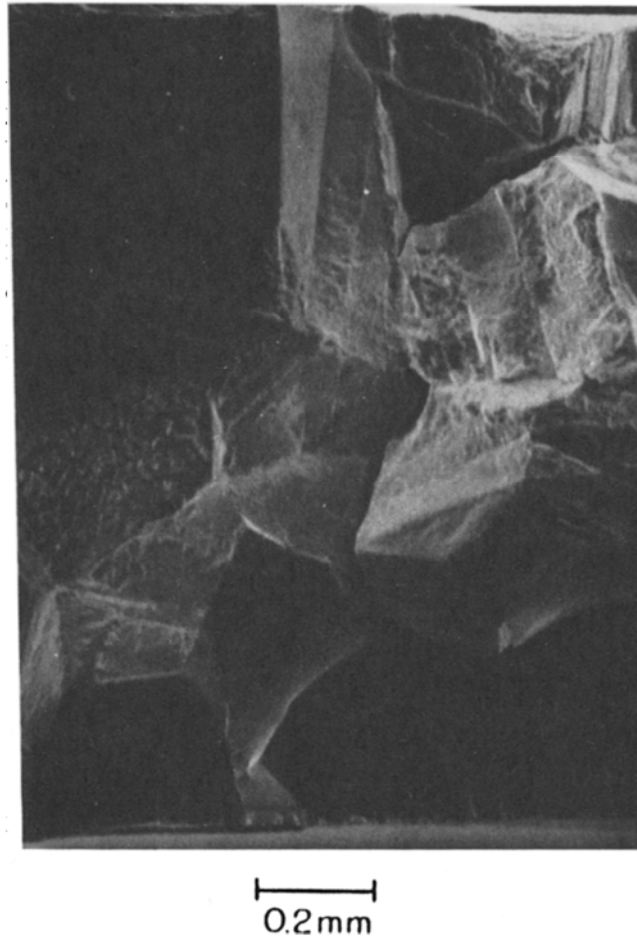
**Figure 27.** Texturing on the grain boundaries in intergranular fracture of oxygen-saturated copper from hydrogen embrittlement [1].

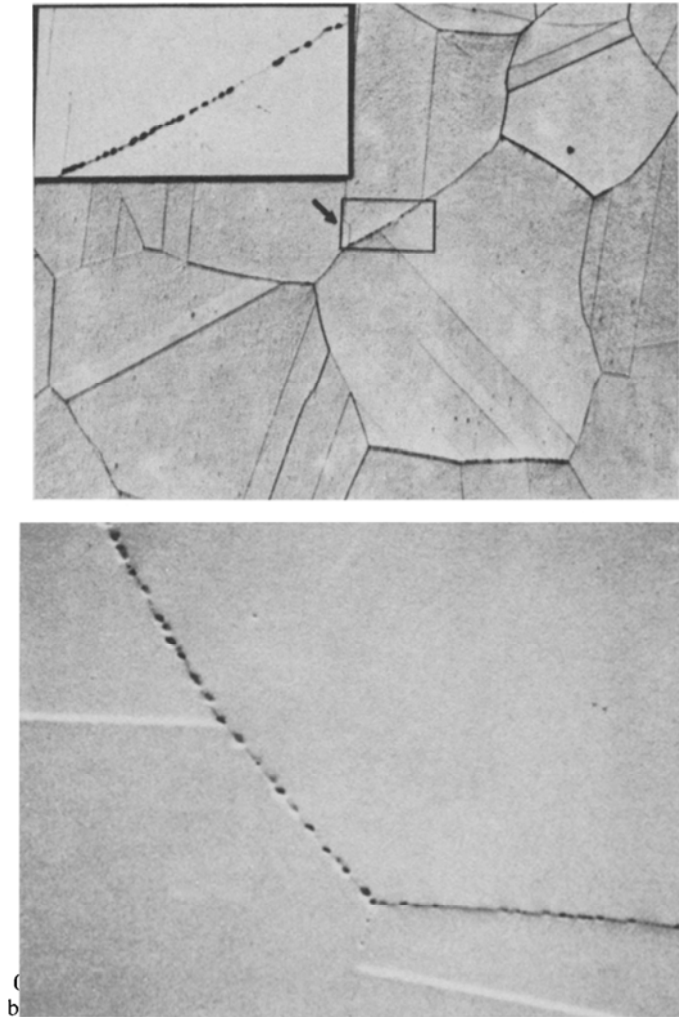
**Figure 28.** Metallographic images of voids or bubbles formed at the grain boundaries due to water vapor evolution in oxygen-saturated copper from hydrogen embrittlement [1].
